Storage Tanks: Snapshots of Failures, Damages and Inspections

Lessons learned from past failures provide insight and know-how needed to inspect and operate storage tanks reliably

Ana Benz
IRISNDT

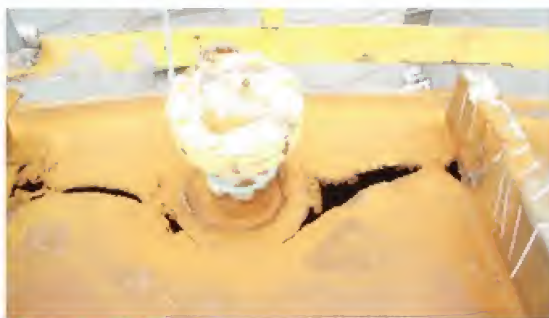
FIGURE 1. After removing the insulation, this tank roof showed numerous openings

sulation. After removing the insulation from a roof, inspection personnel identified numerous through-thickness openings in the roof (Figure 1).

Lesson learned about fixed-roof tanks. Do not walk on the roof without significant hazard diminishing strategies.

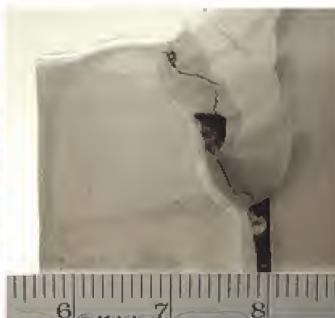
FIGURE 2. Cracks were observed in this tank shell-to-nozzle weld

During hydrostatic testing, an NPS 3 (nominal pipe size) tank drain nozzle leaked. The tank was fabricated to hold diesel fuel. The drain nozzle had one fillet weld joining it to the shell and another joining it to a reinforcing pad (repad), which is a plate formed

to the shape of the tank or vessel around a nozzle for extra strength. The welds had multiple cracks, porosity and non-fusion, as can be seen in Figures 2 and 3.

Lesson learned about welding the drain nozzle in steel tanks. Tanks are welded from the floor up. This means that access to this location (the drain) for welding is challenging. To prevent leaks, the welding passes can be deposited in multiple stages to prevent the formation of continuous leak paths. The hold times for the hydrostatic test should meet and exceed the standard requirements. Fluorescent liquid penetrant could make identifying a minute leak easier.

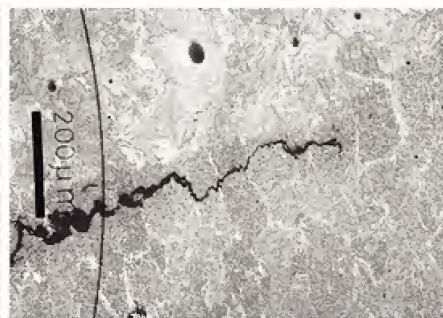
FIGURE 3. A closeup of the tank shell-to-nozzle fillet weld crack shown in Figure 2

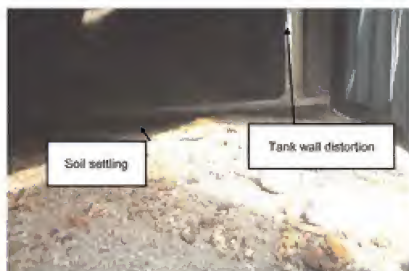
FIGURE 4. Shown here is the tank shell-to-bottom joint. Note the occurrence of soil settlement and tank wall distortion

A fertilizer service carbon-steel tank floor developed cracks in the tank wall to tank bottom joint, as shown in Figures 4 and 5. The cracks had the following characteristics:

These characteristics are consistent with the cracks being due to nitrate stress corrosion cracking (SCC). Additional stresses from the soil settlement under the tank resulted in distortion of the tank wall and floor. These stresses further contributed to the cracks forming.

Lesson learned about the tank floor-to-wall joint. Soil settlement needs to be monitored, and this critical joint (for carbon steels) needs inspection techniques, such as magnetic particles or eddy current, or both.

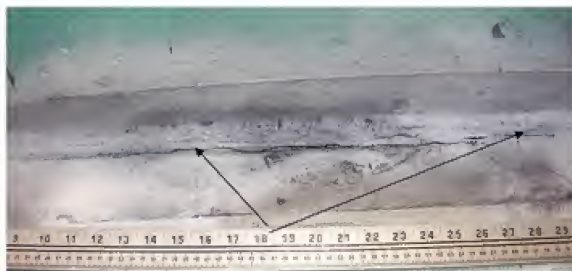
FIGURE 5. Cracks of the tank wall of Figure 4 are identified with magnetic particles

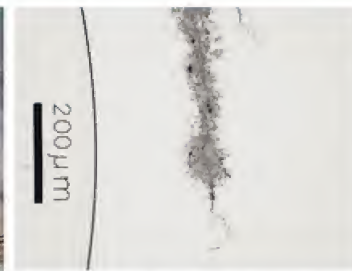
FIGURE 6. For the same tank shown in Figure 4, this metallographic cross-section of the tank floor shows intergranular cracks with oxides/corrosion products

- The cracks developed in the cross-section with the highest stresses in the storage tank. Hydrostatic and welding residual stresses are maximum on this joint
- The cracks had some oxides/corrosion products (see Figures 6 and 7)
- The cracks were intergranular

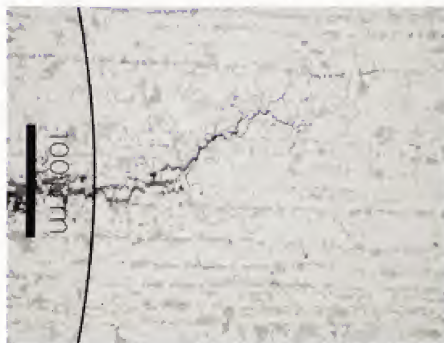
FIGURE 7. Another view of the metallographic cross-section of the tank floor (Figure 6), which shows intergranular cracks (2% Nital etch)

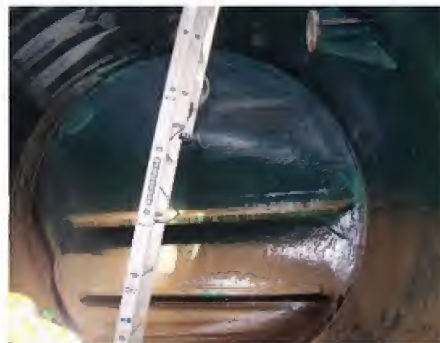
Examining the tanks from the inside, the shape was oval (Figure 8). Also, many of the joints were “whitened.” “Whitening” can develop when FRP is subjected to localized stresses (Figure 9). These damages suggested the tanks had experienced excessive compressive displacement during their partial lift.

FIGURE 8. This septic tank's inside diameter was oval. The internals had separated from the shell

The damaged tanks were replaced. Soil, in accordance to strict (and necessary) installation guidelines, was used to install the replacement tanks. The flow of the underground stream was diverted away from the tanks. The replacement tanks were installed without further surprises.

Lesson learned about installing FRP septic tanks. Buried FRP tanks require special installation practices heralded by their suppliers. Thorough evaluations of the soil con-

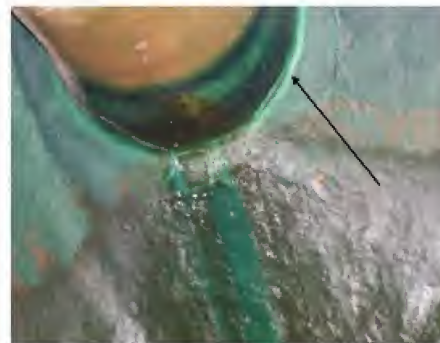
FIGURE 9. For the same septic tank of Figure 8, many of the inside joints had whitened — an indication of localized stress

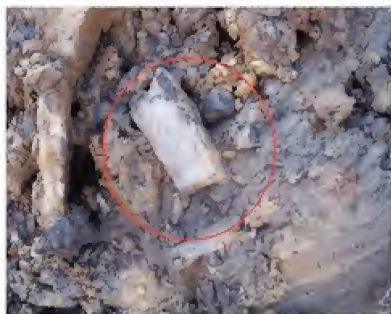
- The soil surrounding the tanks had 0.3 m × 3 m × 0.1 m chunks of ice (Figure 10). Some of these ice chunks had been pressing against the tank shell. FRP is prone to cracking when subjected to localized compressive loads
- The day before the author left the site, an intermittent underground stream was noted a couple of meters below the ground level. The flow was directed at the tanks and would have eroded the ground and support for the tanks, once installed

FIGURE 10. During a summer excavation, large chunks of ice were identified surrounding the septic tank of Figure 8

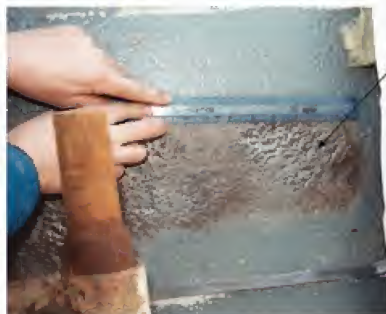
FIGURE 11. Tank floor pits are identified with acoustic emission non-destructive testing

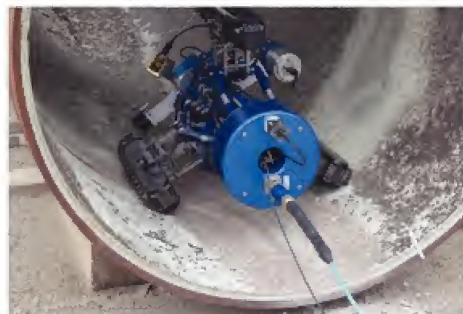
FIGURE 12. Using robotics for visual and coating inspections can reduce the need for personnel to enter confined spaces
